DEPARTMENT OF TRANSPORTATION

Contract #: 04-0120F4Cty: SF/ALA Rte: 80 PM: 13.2/13.9File #: 69.28**WELDING INSPECTION REPORT****Resident Engineer:**Pursell, Gary**Address:** 333 Burma Road**City:** Oakland, CA 94607**Report No:** WIR-010719**Date Inspected:** 10-Dec-2009**Project Name:** SAS Superstructure**OSM Arrival Time:** 1900**Prime Contractor:** American Bridge/Fluor Enterprises, a JV**OSM Departure Time:** 700**Contractor:** Zhenhua Port Machinery Company, Ltd (ZPMC), Changxing Island **Location:** Shanghai, China**CWI Name:** You Qi Guo, Tu Jun**CWI Present:** Yes No**Inspected CWI report:** Yes No N/A**Rod Oven in Use:** Yes No N/A**Electrode to specification:** Yes No N/A**Weld Procedures Followed:** Yes No N/A**Qualified Welders:** Yes No N/A**Verified Joint Fit-up:** Yes No N/A**Approved Drawings:** Yes No N/A**Approved WPS:** Yes No N/A**Delayed / Cancelled:** Yes No N/A**Bridge No:** 34-0006**Component:** OBG/ Tower**Summary of Items Observed:**

WELDING INSPECTION REPORT

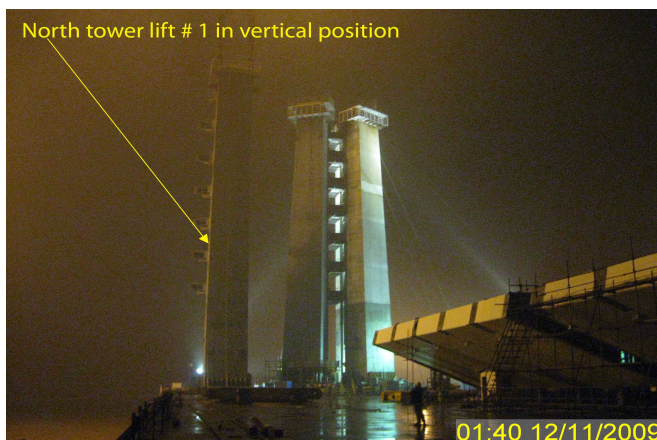
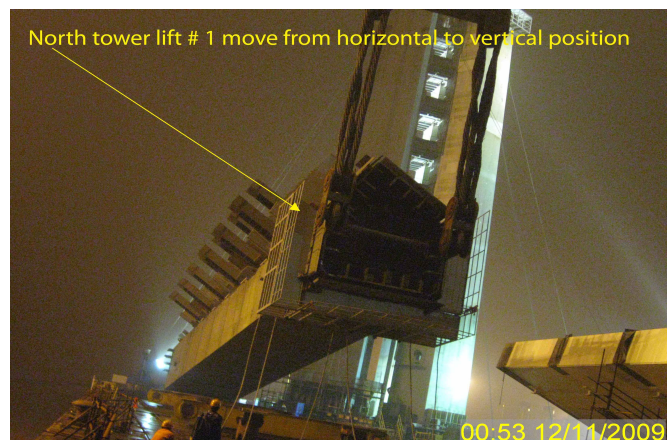
NORTH TOWER LIFT #1

This Quality Assurance (QA) Inspector and Caltrans QA Inspector Mr. Paul Dawson observed ZPMC personnel using a floating crane to move North Tower Lift 1 from the horizontal to the vertical position. This QA Inspector used a digital video camera to record this event. The move appeared to progress smoothly and no problems occurred during this operation. ZPMC positioned this tower adjacent to the other three standing towers (South tower lift #1, East tower lift #1 and West tower lift # 1) and when the tower was lowered to approximately 150 mm ZPMC stopped additional lowering of the tower. It appears there may be interference between some of the shear links that are protruding from various towers, which prevents additional lowering of North Tower Lift 1. As of around 0200 hours most of the ZPMC workers left the heavy dock and North Tower Lift 1 was being supported by the floating crane. For additional information see attached photos.
